What Went Wrong in Cleveland?

Know the Rules When it Comes to Glass Balustrades

by Donn Harter

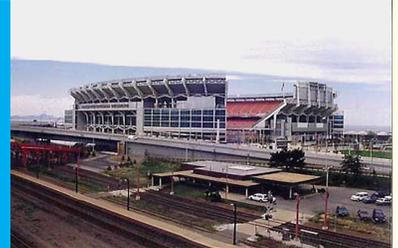
Since the code permits monolithic tempered glass in baluster design, it is the least expensive and therefore the most popular. The phenomenon or built-in hazard that is inherent in some batches of tempered glass, is the presence of an invisible seed or pellet known as nickel sulfide. This seed is believed to be present in one out of 10,000 lites of tempered glass. This seed grows steadily until it causes sudden and total destruction of the glass (see *USGlass April 1998, "Temper, Temper," page 66*).

A celebrated example of this baluster failure was witnessed recently at the Cleveland Stadium where several of the lites simply blew up and fell to the seats below. There are more than 1,800 balusters in the Cleveland Stadium. Fortunately there were no spectators in the stadium at the time or potential injury could have been very serious. This does not constitute a code violation but does point out the need for code change where balustrades are located above walking or seating locations.

Just a few miles from Cleveland's skyline, the Cleveland Stadium was the site of a baluster failure when several of more than 1,800 lites crashed to the seats below.

The Cleveland Stadium balustrade design was in code violation since there was no top rail. The balusters of approximately 18 inches in height were located on top of a 24-inch pony wall. The codes require a rail on the top of the glass at a minimum of 42 inches above the walking surface. This requirement is designed to protect a person who is leaning on the railing from falling if the baluster fails. Owners and architects object to the rail because it is vision block at that point. Too bad! Life safety is more important. The utilization of a top rail may have reduced the amount of fragmented tempered glass that vacated the opening.

The California Glass Association (CGA) has a Task Group working on glass railing systems, which would develop national standards for life safety design. There will be a number of guidelines developed and published to help guide architects and contract glaziers in the proper design. Certainly, one of the recommendations will be the use of tempered or heat-strengthened laminated glass where an unprotected walking surface exists below. We will support any American Society for Testing Materials endeavors in this area. In the meantime, something must be done and the CGA is embarking on offering some sound practices with a nationally recognized group of railing experts. This group includes architects, engineers, building officials, manufactures, and contract glaziers. The finished product will not compromise design, but will save lives.
